FAQ\_CM20\_001 – Misalignment of the roller head – causes overlap problems!

Work: Alignment of the roller head

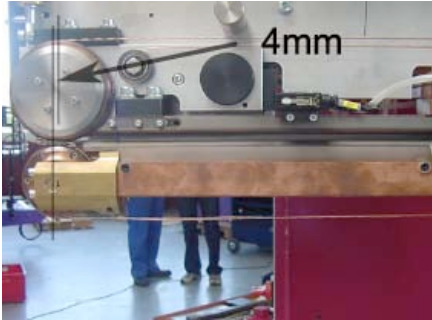
**IMPORTANT:**

The center of the upper roller head must be approx. 4mm ahead of the center of lower roller head. This setting supports the achievement of accurate overlap during the welding process.

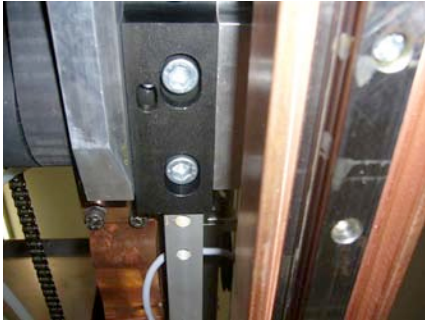
Undo the 2 x M8 screws of the oscillator to loose the connection to the welding pressure.

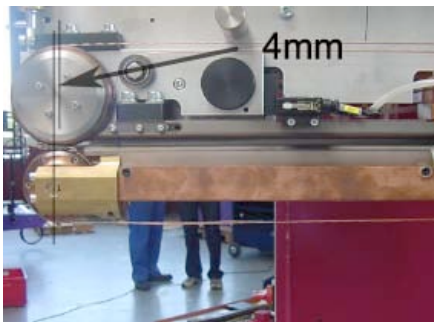
Undo the 2 x M12 screws of the oscillator.

Adjust the oscillator, in order to achieve the offset of 4 mm (see explanation in the first frame).

Tighten the oscillator.

Question: Are both wires lined up accurately?  
If not, undo the oscillator once more to shift it slightly sideways.
