FAQ – CM26_005 Visual isolation check on the induction coil of the PowerCure.

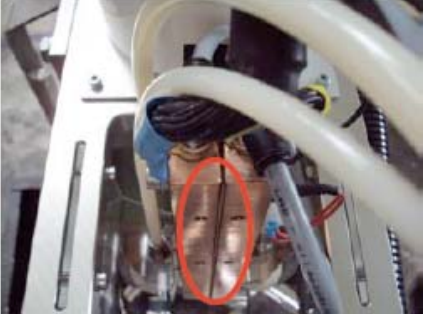
A close-up photograph of the induction coil assembly. Two copper plates are visible, with a red oval highlighting the gap between them. The plates appear clean and free of any residue.

Check the two copper plates where the condenser is installed.

=> looks the isolation between those copper plates okay? It should be clean and have no water or marks, which look burned.

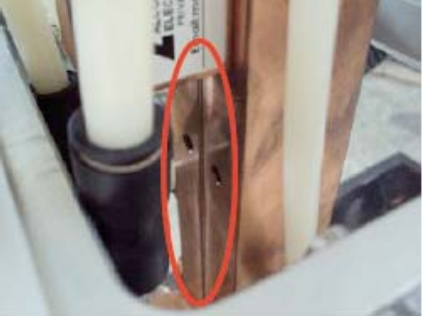
A close-up photograph showing the condenser mounted between the copper plates. A red oval highlights the condenser and its mounting screws. The condenser is mounted parallel to the copper plates.

Check also the mounting of condenser. Are the screws fixed well and condenser mounted parallel to the copper plates. Do see any compound on the condenser or plates? If yes, clean it.

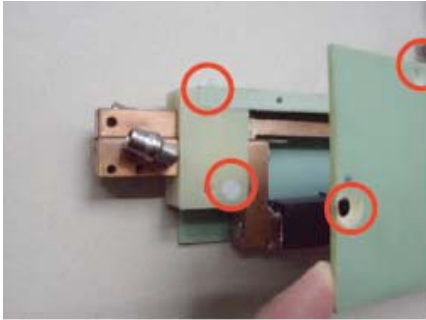
A photograph showing the connection of the induction coil to the power source. A red oval highlights the connection point. The area is clean and free of any marks or water.

Check the connection to induction coil.

=> looks the isolation between those copper plates looks okay? It should be clean, have no water or marks, which look burned.

Check now the coil inside. To do that you have to disconnect the coil to remove it. Undo the screws of side cover and the coil holder.

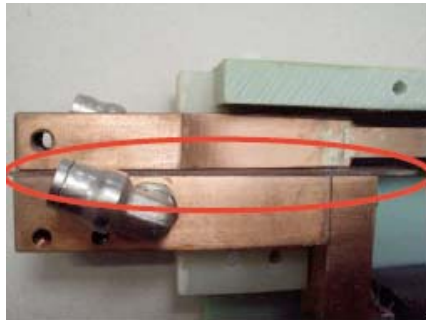
Check the isolation between the copper parts and check both sides.

=> It should be clean and have no water or marks, which look burned.

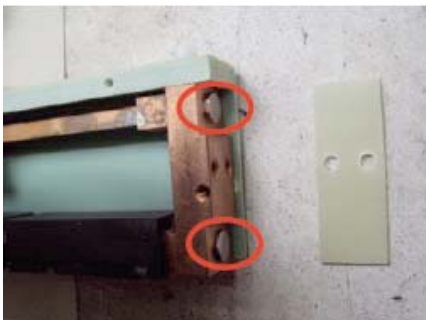
On the other side of the coil remove also the side cover and also the end cover.

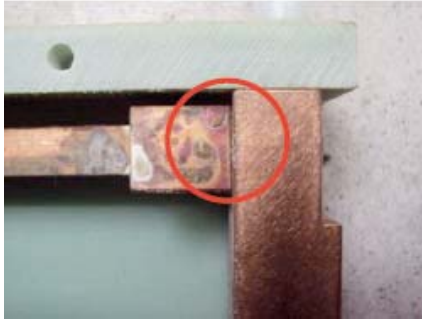
Check the screws, where they connect to the coil part.

=> Are they fixed well? No burned marks between coil parts and the connection part?
